Structural Inspection by RPAS (Drones): Quality Work with Preventive Guarantee

Keywords: Drones, RPAS, Inspection, Structure, Bridge

On November 6, 2021, the author of this article participated in a viaduct detailed main inspection with other professionals, with the exclusively experimental purpose of verifying the applicability of drones to carry out this type of inspection.

The viaduct inspected was the viaduct called La Jarosa, located near from Madrid. Specifically, the structure is located at the kilometer point (K.P.) of the highway AP – 6, very near to a mountain range (Sierra de Guadarrama) and very close to a dam as well (Figure 2). The bridge crosses a minor road and a small stream (Fuente Corneja).

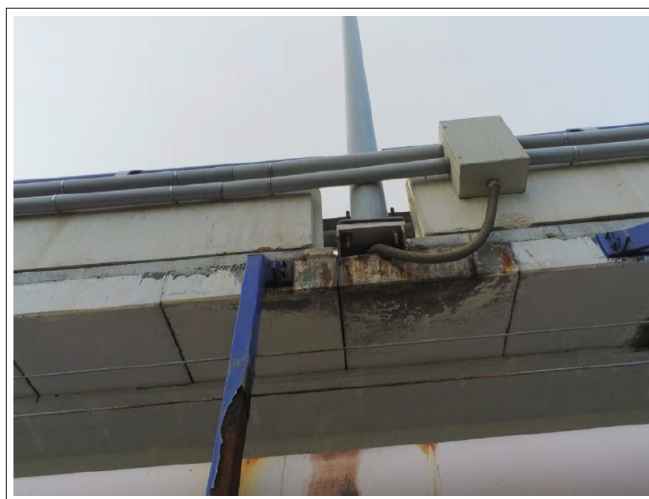
Damage due to corrosion has been observed in several of the elements of the structures (Figure 9, Figure 10, Figure 11 and Figure 12). As we have already pointed out in section 2 of this article, the condition due to corrosion has already motivated previous actions. The location of the structure in a mountain area, where winter frosts are frequent and severe, makes it necessary to keep in mind the action of ice-thaw, as well as the crystallization of salts. This concentration of moisture, and the alternation of moisture - dryness, causes corrosion products to appear as a result of the reaction of oxygen and certain metals, mainly steel, in the presence of water or moisture [21].

We were also able to see salt stains, especially chloride stains, probably due to the winter dumping of salt on the road surface to combat ice and snow. Although the extended dosage is unknown, it is known that the extended salt is rock sodium chloride (not sea salt). When de-icing salts are poured on or under roads, chloride corrosion phenomena are very frequent, resulting in the formation of reinforcement corrosion products, as a consequence of localized acidification at the contact points of chloride ions (in a certain concentration), which gives rise to a localized oxidation reaction, in the presence of water [22].

Figure 9: Signs of corrosion in concrete and metallic elements. Note also the poor support of the staff, as two of the four bolts at the rear cantiléver (photograph taken with the Anafi Parrot drone).

The poles of the luminaries are also part of the structure. Their safety and stability is very important to avoid accidents. Upon inspection of the staves, we discovered that they were not properly anchored to the bridge deck [32] [33]. Not all the fixing screws of the base plate of the lamp support were fixed to the corresponding element (Figure 9).

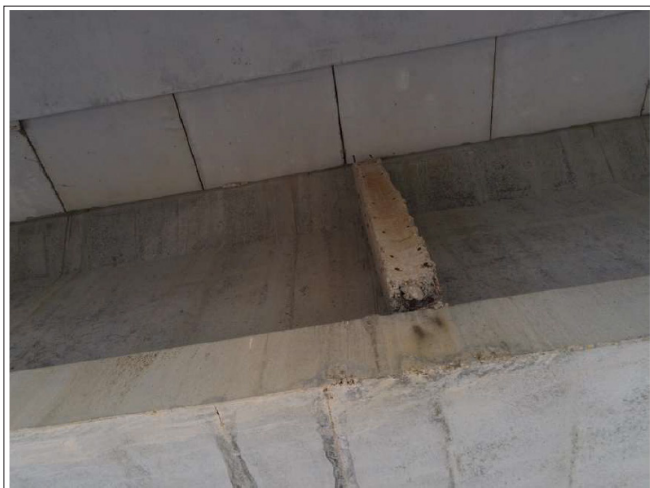
Figure 10: General View of a Concrete Brace, Arranged in the Web of a Precast Beam (Photograph Taken with the Anafi Parrot Drone).

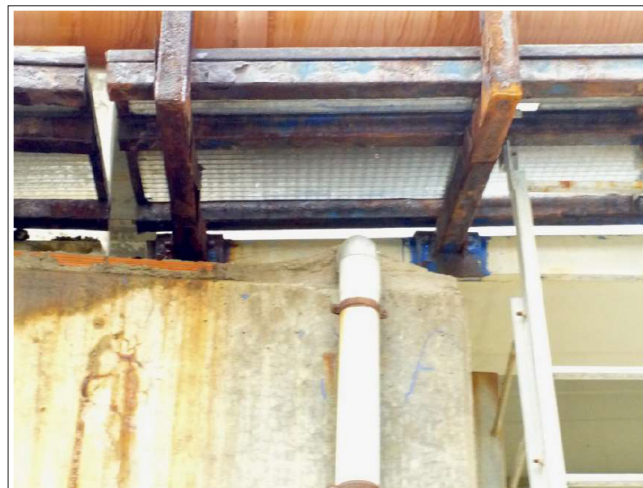
Figure 13: Detail of the Area Photographed in Figure 12, Where the Corrosive Phenomena Can be Observed in Greater Detail (Photograph Taken with the Anafi Parrot Drone)

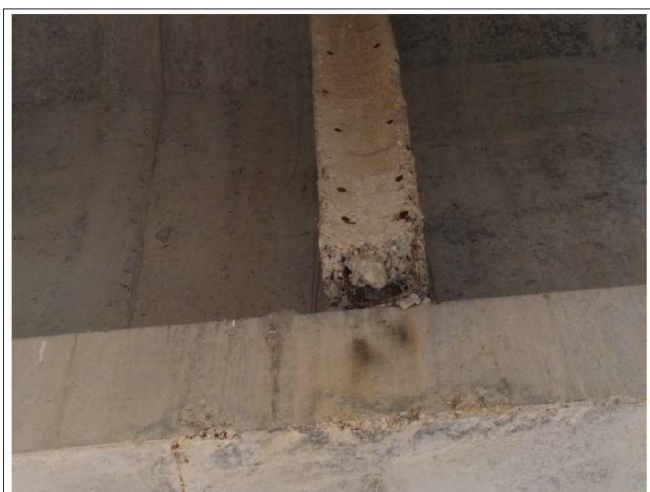
Figure 11: Detail of the Element in Figure 10, Where a Chipping and the Consequent Corrosion of the Exposed armor Can be Seen (Photograph Taken with the Anafi Parrot Drone).

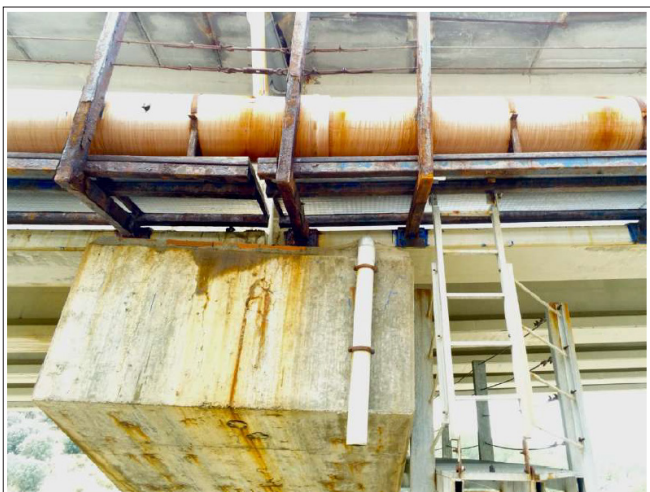
Figure 12: General View of the Shaft of One of the Piers, Where Corrosion Phenomena can be Seen that Affect different Constituent Materials of the Structure (Photograph Taken with the Anafi Parrot Drone).

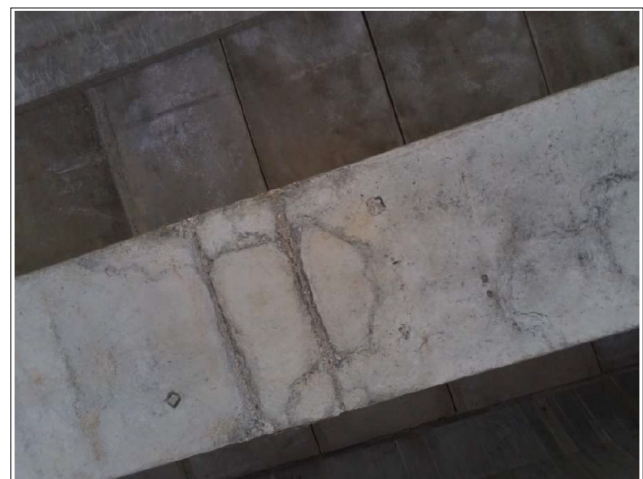
In various concrete elements, part of the corrosive phenomena may be related to the scarce coating of the steel reinforcement, as has been recorded with the drone. The most significant elements in which this defect has been observed have been the lower faces of the prestressed beams in which the reinforcement frames have been perfectly visible (Figure 14). Despite the fact of the spectacular images, the structural importance of this damage is, in principle, nil. However, a regular check is very convenient [31].

Figure 14: Semi-Exposed Steel Reinforcement in Prefabricated Support Beam, as a Consequence of a Scarce Covering, Showing the Reinforcement Frames (Photograph Taken with the Anafi Parrot Drone).

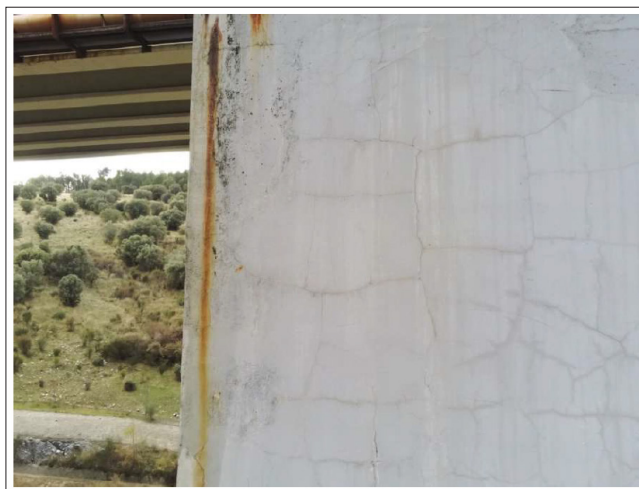
In some of the piers, we detected defects related to the hardening phase of concrete. It means that, whatever reason, the concrete had not set or hardened properly during construction (Figure 15). These phases, the concrete curing phase and the concrete hardening phase, are particularly critical moments [35].

During the hours immediately after concreting (between 2 hours and 10 hours), the concrete, still fresh, suffers plastic settlement, suffers plastic shrinkage and suffers superficial drowning. The hydration heat causes During the hours immediately after concreting (between 2 hours and 10 hours), the concrete, still fresh, undergoes plastic settlement, undergoes plastic shrinkage and suffers from superficial drowning. The hydration heat generated by the cement paste (that makes up the concrete) setting causes this damage [21,22,35].

Figure 15: Fissuring on the Map that Denotes Injuries Due to Plastic Shrinkage, Hydration Heat or Suffocation (Photograph Taken with the Anafi Parrot Drone)

All these injuries are ugly: the damage is mainly cosmetic. They do not compromise the structural safety of the structure. However, they can cause durability problems in the structure, especially in the element that appears. These cracks are a risk for the durability of the steel bars and for the mechanical bonding behavior between these bars and the concrete, because the cracks are aligned with the bars. This circumstance forces special precautions to be taken in areas of medium or high aggressiveness. The first step is routine control, something the drone is very useful for. The drone allows the capture of a photograph in each flight, so that the evolution of the damage can be visually compared.

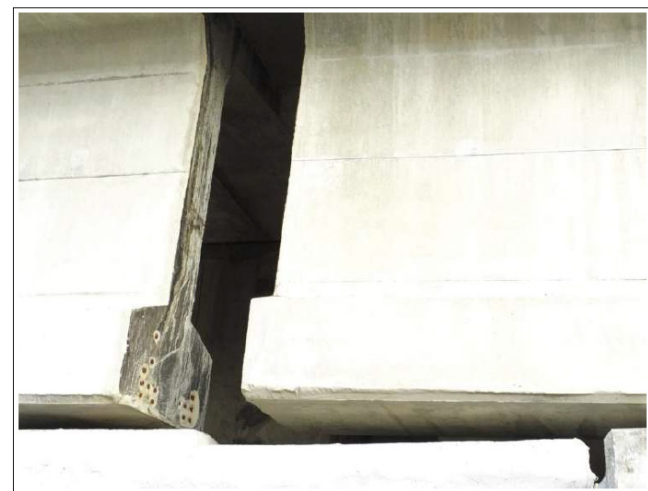
At the ends of the lower flanges of some beams, slight chipping or chipping was detected, unimportant, beyond having left the prestressing reinforcement exposed (Figure 18 and Figure 19). They are probably due, if they have any structural explanation, to adherence failures of the final coating mortar. Its possible evolution should be checked in successive subsequent inspections.

Figure 18: Detail of One of the Beams, Where the Chipping of the End of the Wing Area can be Seen, Leaving the Prestressing Tendons Exposed (Photograph Taken with the Anafi Parrot Drone).

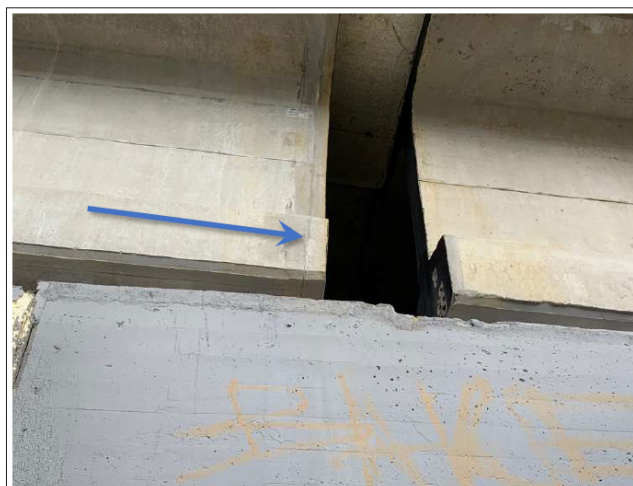
Figure 19: Two Beams Detail, where two Chips can be Seen at the Ends of the Wing Area, Leaving, as seen in the Beam on the right, the Prestressing Tendons Uncovered (Photograph Taken with the Anafi Parrot Drone).

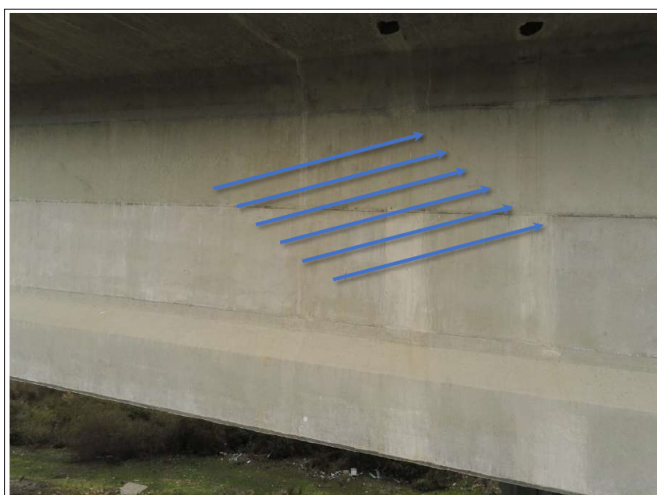
The most noteworthy damage of all those that have been detected has been, with no doubt, the diagonal cracks that, on the face of the web of some of the beams, have been observed in the vicinity of the support (Figure 20). The structural origin of these cracks must be found fundamentally in the shear stress, although it could be accompanied by assembly or transport torsion of the piece [21,22]. Beams shear stress measures the bending moment variation along the beam directrix [39]. A deeper analysis of this crack would reveal whether it is a symptom of a loss of safety level, in order to reduce the structural significance of this damage [40].

Figure 20: Diagonal Crack in the Beam Web, Caused Presumably by a Shear Stress (Photograph Taken with an Anafi Parrot Drone).

When a crack of this type is observed during an inspection, support devices should be sought as soon as possible. A detailed visual inspection of the beam in all the visible faces is necessary, and the drone can carry it out perfectly, as has been stated here [41]. A clear definition of the static scheme of the complete slab and of the section under study is precise, because this damage can be important: the associated failure mode could lead to sudden collapse, without warning [21,22].

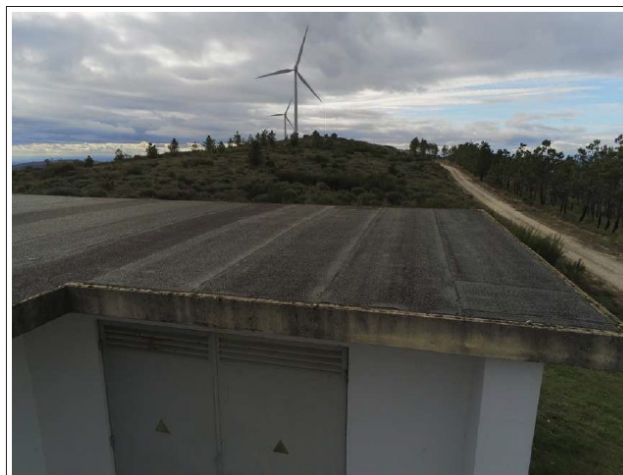
Figure 24: Transformation and Control Center Roof Inspection in a Wind Farm Located in Torre de Moncorvo, Bragança (Portugal) for the Location of Deficiencies Causing the Humidity Recorded Inside (Photograph Taken by the Author with an Anafi Parrot Drone).

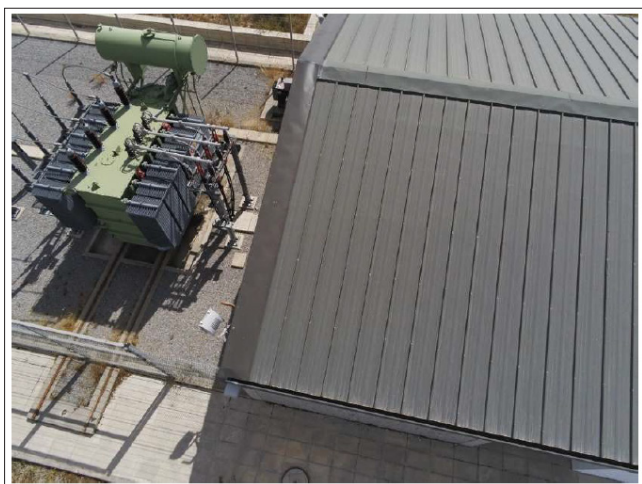
Figure 26: Electrical Substation Roof Inspection in Cinfães, Viseu (Portugal) to Verify Damage after a Heavy Hailstorm (Photograph Taken by the Author with an Anafi Parrot Drone).
