Employment of RPA (Remotely Piloted Aircraft) in Identifying Imperfections in the Asphalt Pavement of the Transoeste Bus Rapid Transit (BRT) System

The Brazilian Road network is constantly used by the population and its maintenance is an essential charge to ensure the performance of the pavement. Therefore, the verification of asphalt conditions is extremely relevant to analyze their structural and functional qualities. It is noteworthy that this verification is usually performed by technicians manually being the results slow and often with impalpable and partial analysis. Given this, we see the need to study the benefits of obtaining this information indirectly without the need for in loco man. In this work we will focus on the use of Remotely Piloted Aircraft System to obtain the images that will enable the analysis of asphalt conditions. The place where the study will take place is the corridor of BRT Transoeste in Rio de Janeiro, which connects the region of Barra da Tijuca to Santa Cruz and Campo Grande, passing through Guaratiba and Recreio dos Bandeirantes. The following procedures will be adopted: Flight Planning with RPAS observing GSD Ground Sample Distance advocated by

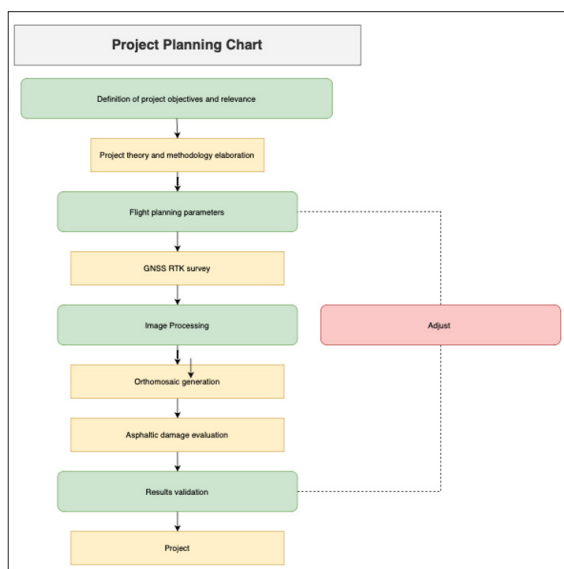
Figure 1: Project Development Stages
Source: Authors (2023)

The methodology adopted for the development of the project in question consisted of several sequential steps that correspond to the project implementation phases, as highlighted in the diagram in figure 1.

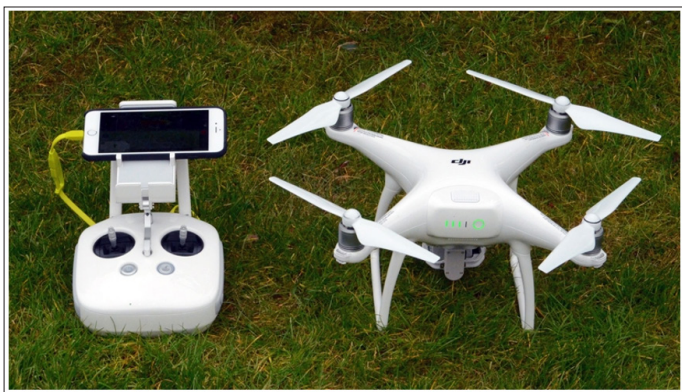
Figure 3: RPA Equipment used
Source: Adapted from [8]

For the images acquisition, the RPAS Phantom 4 Pro from the DJI brand, owned by one of the authors of the article, was used (Figure 3). The aircraft is equipped with a 20-megapixel 1-inch sensor capable of recording 4K video. Additionally, its Flight Autonomy system includes two rear vision sensors and infrared detection systems for a total of 5 obstacle detection directions and 4 obstacle avoidance directions. Along with the radio control, a smartphone was used that connects to the radio control via Bluetooth technology to upload data. This device was used to upload flight plans and monitor the BRT Transoeste mapping process. The PIX4D Capture software was used for flight planning and for monitoring during the Phantom 4 Pro flight, the application used was DJI GO 4.

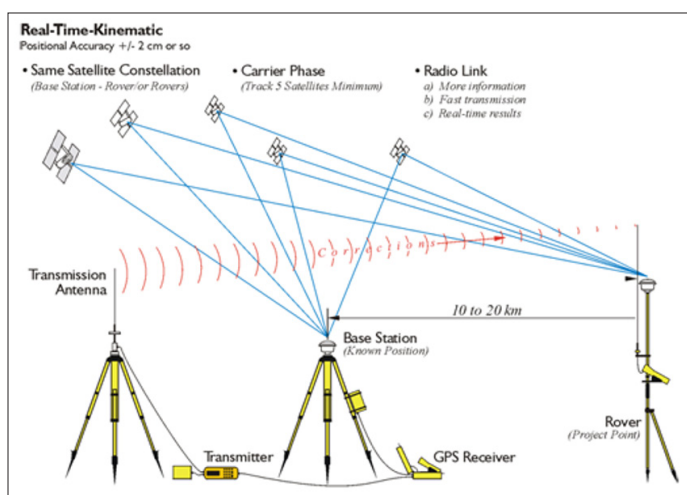
Figure 4: Network RTK Method
Source: Adapted from [12]

Real-time relative positioning called Real-Time Kinematic (RTK) has been widely used, as it allows the user to determine their accurate position in real time [9]. This method can achieve centimeter accuracy, without the need for further data processing, if the solution to the ambiguities obtained is reliable [10]. In network RTK, instead of just one reference station, there are several continuous monitoring stations connected to a central server, from which correction data is distributed to mobile receivers via the Internet (Figure 4) [11].

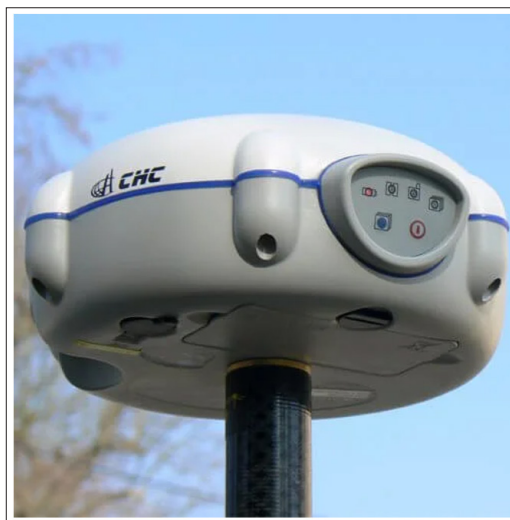
Figure 5: GNSS Receiver used
Source: Adapted from [13]

identification as ONRJ, located inside the National Observatory in Rio de Janeiro (SAT Code: 93921.37), since with the distance between the reference station and the study area of approximately 30 km, it was possible to obtain results with horizontal and vertical accuracies of less than 5 and 7 cm, respectively.

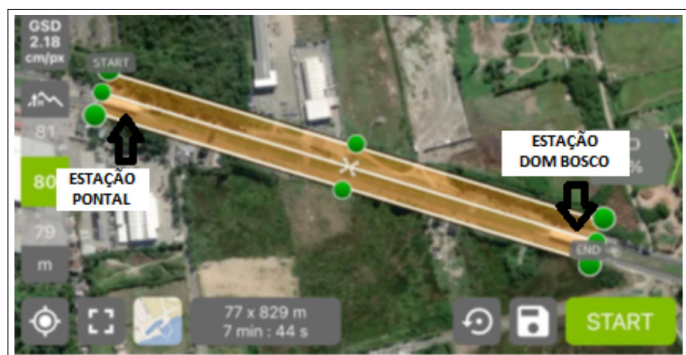
Figure 6: Flight Planning
Source: Authors (2022)

to the drone's flight height when mapping. It was defined that the recommended value for the objective of this work corresponds to 2.5 cm. A corridor mapping is characterized by a long, narrow area. This type of technique is very common, especially on highways. The chosen flight direction was Southeast – Northwest, precisely so that the flight range would be longer, making the RPAS gain battery autonomy throughout the flight. In total, three flight lanes were needed to cover the BRT Transoeste area between Pontal and Dom Bosco stations, as shown in figure 6.

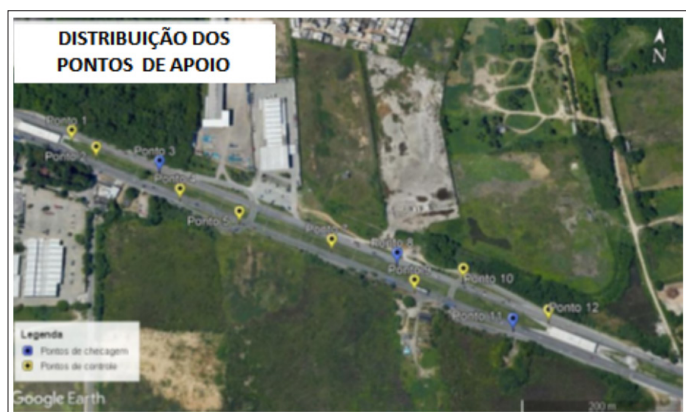
Figure 7: Distribution of Support Points
Source: Authors (2022)

Normally, at least 5 control points are used, distributed homogeneously, covering the entire area over which the aerial survey with RPAS will be carried out. Considering the objective of mapping, the precision required for the final product, as well as in very large areas that have significant variation in altitude, it is possible that a greater number of control points will be allocated. Hence, the greater the number of control points, the better the products generated, this quantity will depend on the extent of the area that you wish to survey [18]. However, it is worth checking to what extent it is economically viable to install so many control points. In this work, 12 support points were collected within the area of interest, as shown in figure 7, to support the RPAs survey. These points were raised using the RTK NTRIP technique. It should be noted that 1 point was removed from the survey due to a high positional error. Finally, the distribution was as follows:

- 8 points were used as control points;
- 3 points were used for checking.

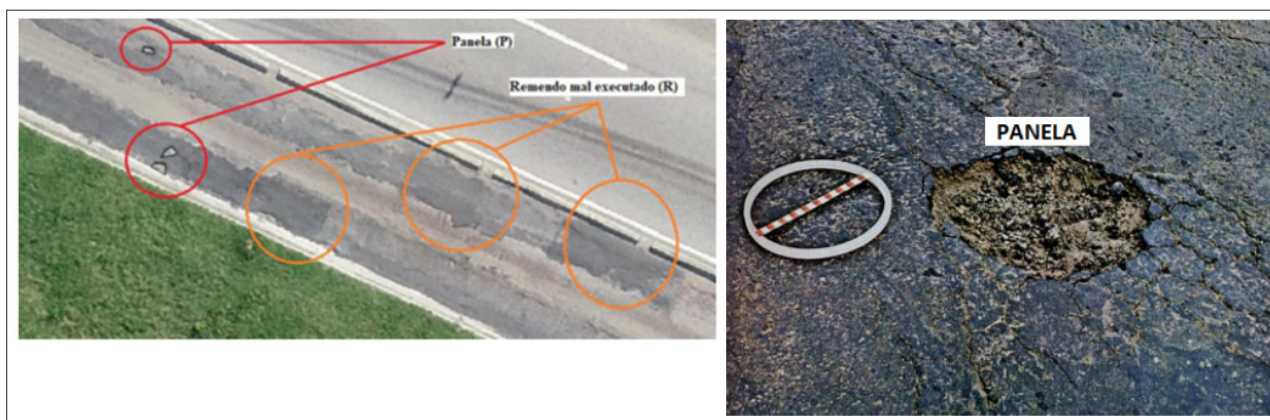
Figure 9: Classification of Irregularities
Source: Adapted from DNIT_005_2003_TER (2022)

From the analysis of the orthomosaic and the classification of asphalt faults from the DNIT, it is possible to measure what type of irregularity occurs on the pavement. In addition to characterization, it is also possible to extract geometric information from the faults. In the section of the BRT Transoeste shown in Figure 9, the presence of two different types of asphalt faults is clearly observed, namely “Panela” (Pan) and “Remendo” (Pothole filling) poorly executed. According to the DNIT Standard, a pan or hole (P) is a cavity that forms in the coating for various reasons (including lack of adhesion between superimposed layers, causing layers to peel away), which can reach the lower layers of the pavement, causing disintegration. of these layers. According to the standard, patch (R) is a pan filled with one or more layers of pavement in the operation called “pothole filling”. It is divided into deep patch (the one in which the coating is replaced and, eventually, one or more lower layers of the pavement, usually presented in rectangular shape) and superficial patch (correction, in a localized area, of the coating surface, by application of a bituminous layer.

In the case of irregularities classified as Panel (P), “holes” as they are commonly called, are noticeable. And in the irregularities classified as Patch (R) it is visible that they are deep patches (since they are rectangular and have a large layer of asphalt mass) however, they are poorly executed, so that the terrain is completely irregular.
