Structural Inspection by RPAS (Drones): Quality Work with Preventive Guarantee

Keywords: Drones, RPAS, Inspection, Structure, Bridge

On November 6, 2021, the author of this article participated in a viaduct detailed main inspection with other professionals, with the exclusively experimental purpose of verifying the applicability of drones to carry out this type of inspection.

The viaduct inspected was the viaduct called La Jarosa, located near from Madrid. Specifically, the structure is located at the kilometer point (K.P.) of the highway AP – 6, very near to a mountain range (Sierra de Guadarrama) and very close to a dam as well (Figure 2). The bridge crosses a minor road and a small stream (Fuente Corneja).

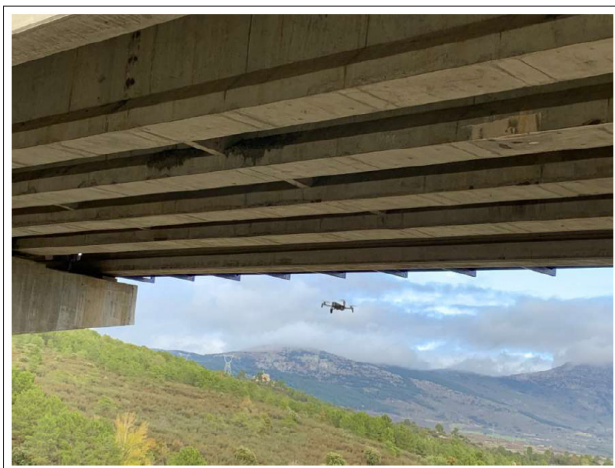
Figure 8: Anafi Drone Flying Over Under the Beams that Support the Deck in the First Span (the Nearest to Madrid) to Recognize the Constituent Elements of the Viaduct (author's Photograph)

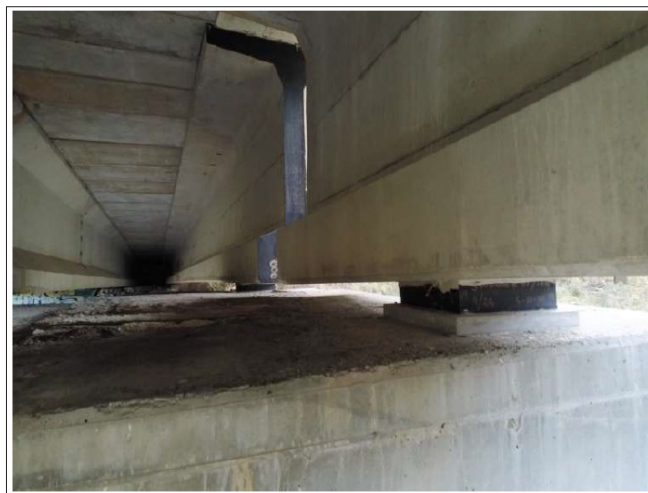
The use of the drone allowed access to the interior of the deck-beams assembly (Figure 16), to be able to observe the parts of the beams not visible from the outside (Figure 17).

Figure 17: View Under the Deck of the Structure Towards Madrid, in Which it is Observed, in Addition to the Interior Faces of the Prefabricated Beams and the Precast Slabs, the Support Devices Under Some of the Beams (photograph Taken with an Anafi Parrot Drone)

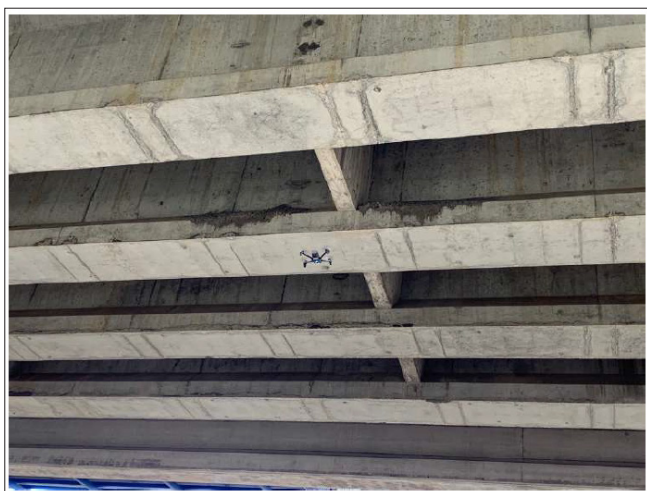
Figure 16: View of the Drone Approaching the Space between Two Beams, for the Analysis of the Non-Visible Faces of the Beams (author's Photograph)
